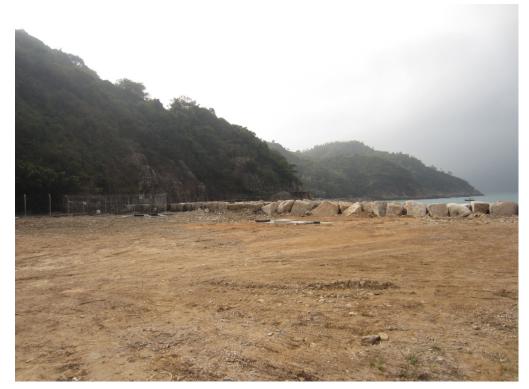
*Photo 1 – Construction of the new beach manhole has been finished and the site has been reinstated to its original conditions.*

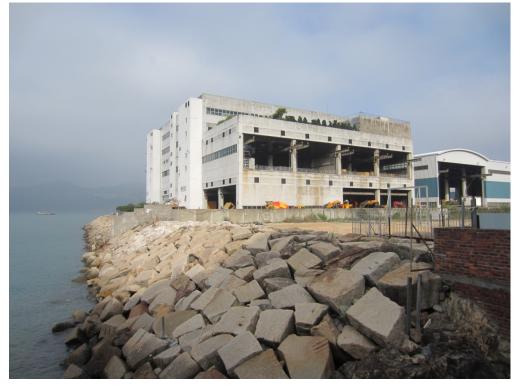
Photo 3 – Artificial Seawall in front of the cable landing point has been reinstated to its original conditions.

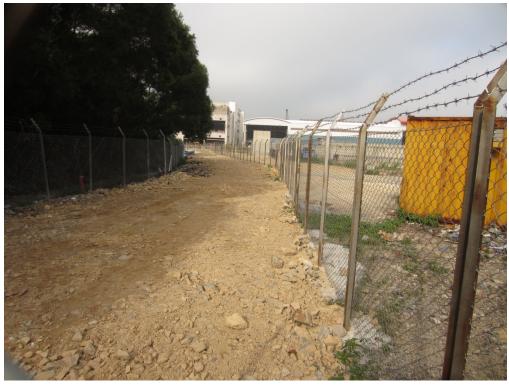
Photo 2 – Construction of the land duct has been finished and the site has been reinstated to its original conditions.

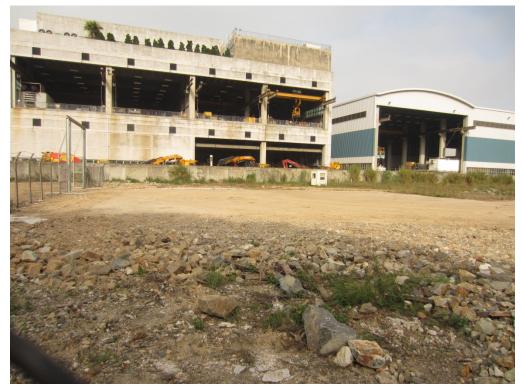
*Photo 4 – Areas in vicinity of the cable landing point have been cleaned.*
