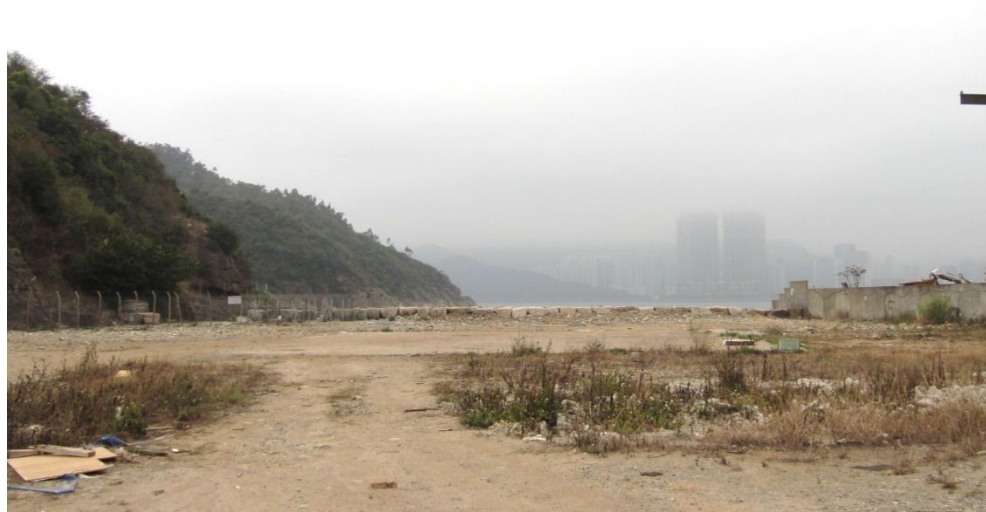
*Photo 1 – Hoarding fences of the new beach manhole have been dismantled and the site has been reinstated to its original conditions.*

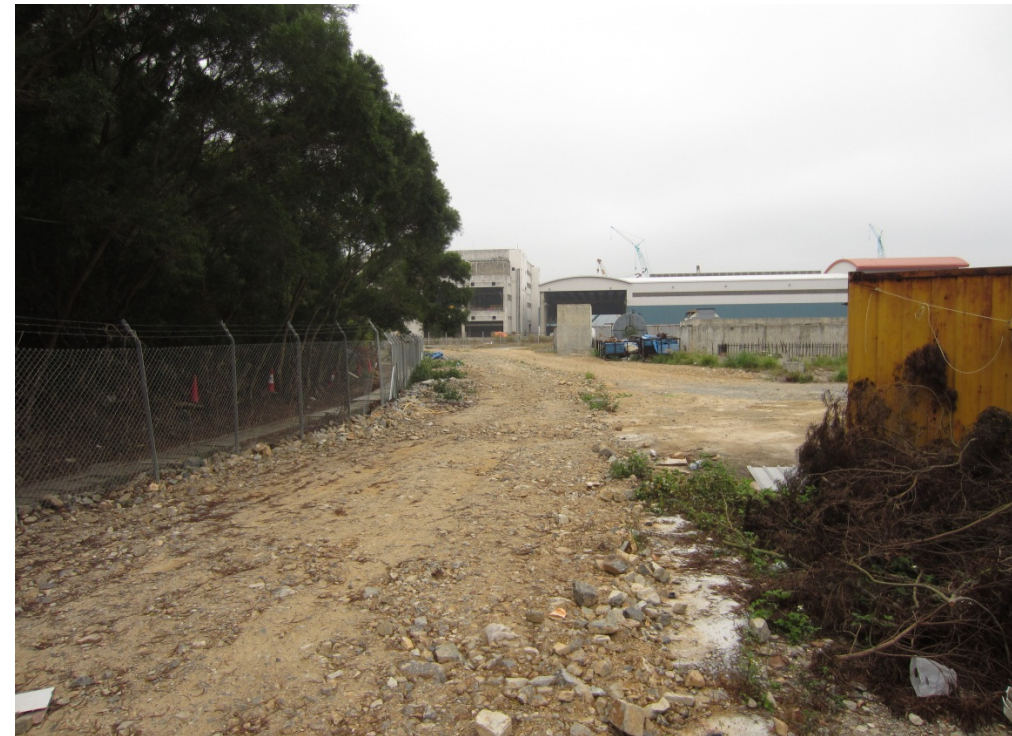
*Photo 2 – Hoarding fences of the land duct have been dismantled and the site has been reinstated to its original conditions.*

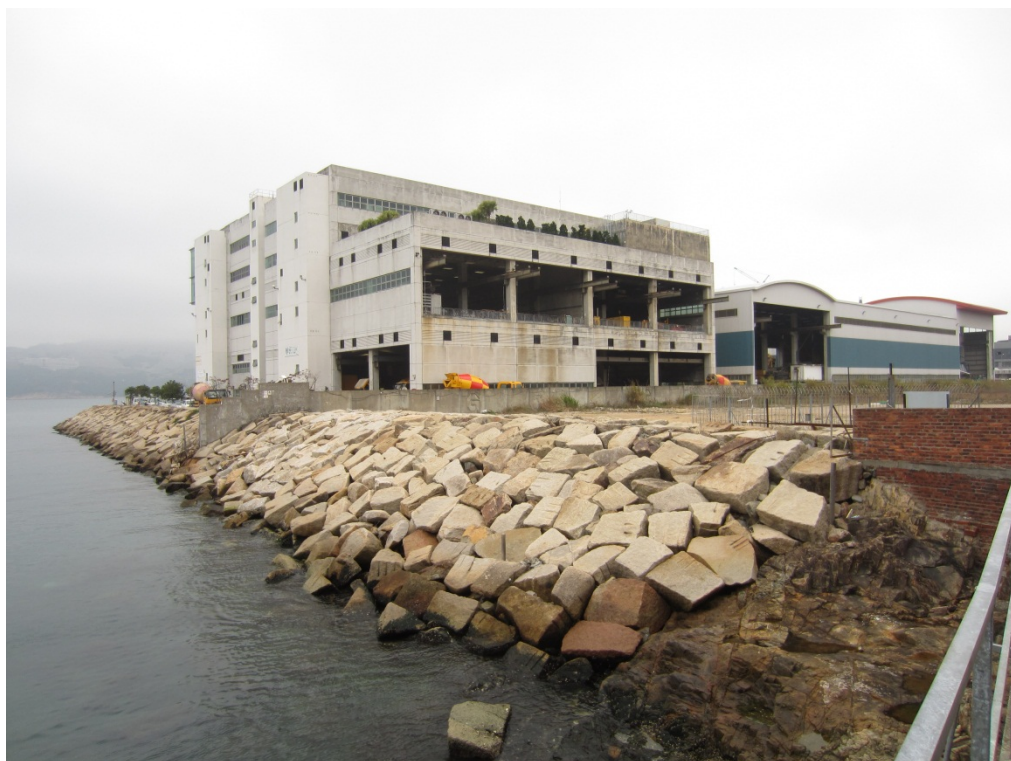
*Photo 3 – Artificial Seawall in front of the cable landing point has been reinstated to its original conditions.*

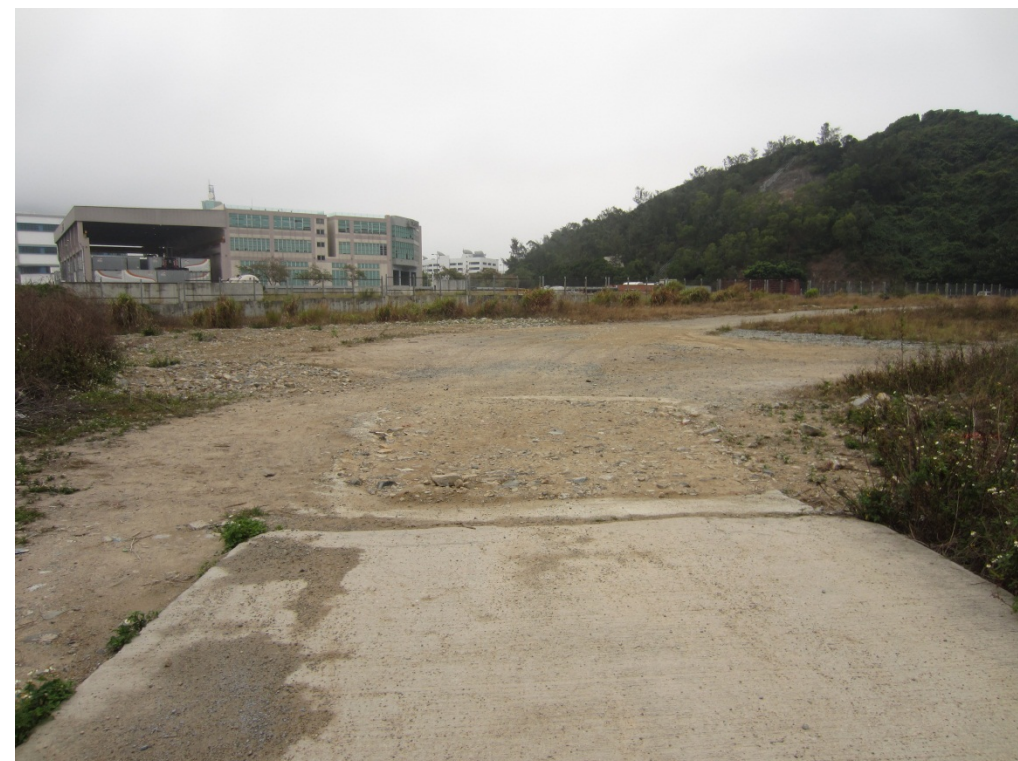
*Photo 4 – Areas in vicinity of the cable landing point have been cleaned.*
