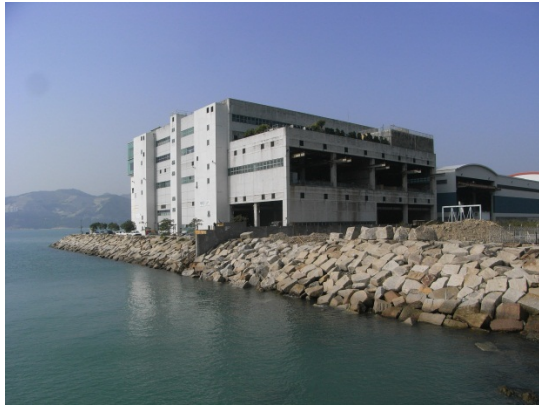
*Photo 1 - The silt curtain was decommissioned off the seawall.*

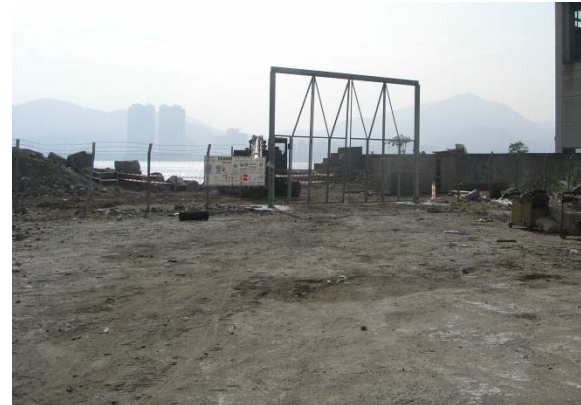
*Photo 2 - The construction site was found to be largely clean and tidy with rubbish seldom seen on site.*

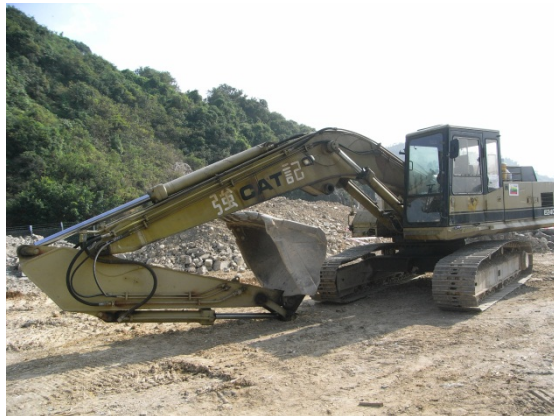
*Photo 3 - Idling engines/plants were observed to be turned off.*

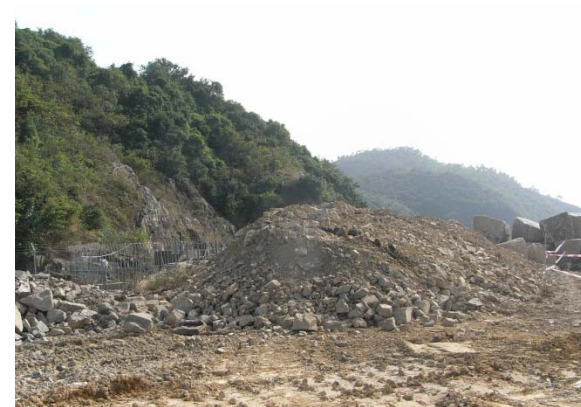
*Photo 4 - Stockpiles of the excavated materials were observed to be exposed.*
