Asia Submarine-cable Express (ASE) – Tseung Kwan O

Tenth Weekly Site Inspection Report

12 December 2012

10th Weekly Site Inspection Report

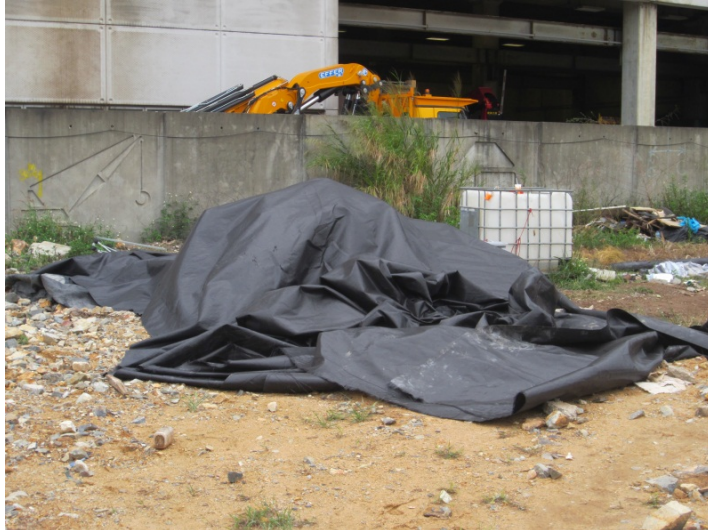
- (i) Impermeable sheets were observed to have been placed on the stockpiles of excavated soils and rocks that were not in use (*Annex D Photo No. 1*).

Photo 1 – Impermeable sheets were observed to have been placed on the stockpiles of excavated soils and rocks that were not in use.

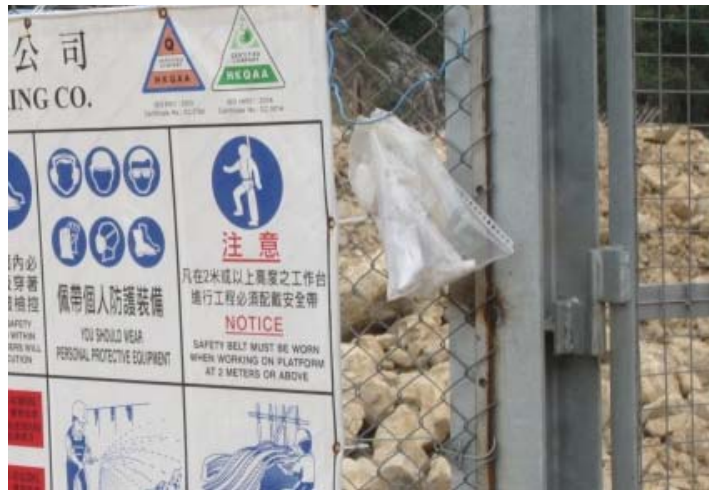
- (iii) The EP copy, which is required to be displayed conspicuously at the vehicular site entrance in accordance with Condition 1.5 of the EP, was sodden and damaged by previous rainfall (*Annex D Photo No. 2*). The Contractor was reminded to replace the damaged copy with a new one for public's information of the on-going Project at all times. Follow-up action actions by the Contractor will be checked in the next week's site inspection.

Photo 2 – The EP copy displayed at the vehicular site entrance was damaged.

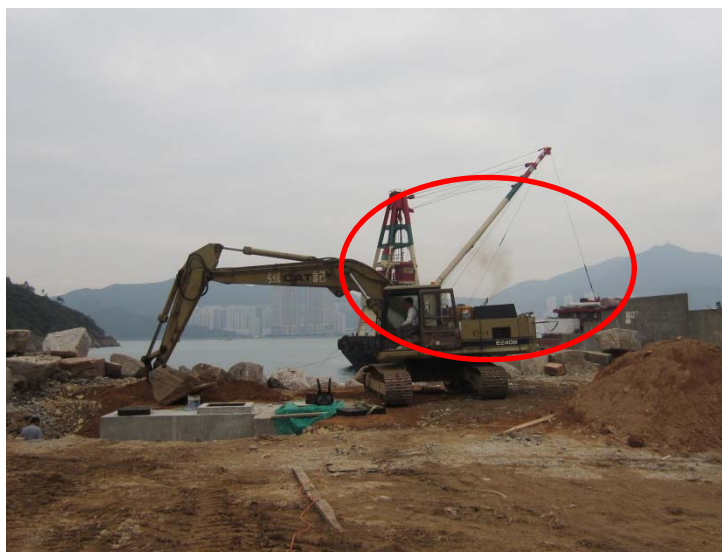
- (iv) Dark smoke was seen rising from the crane truck used to backfill the excavated rocks and soils (*Annex D Photo No. 3*). The Contractor was reminded to well maintain all plants and equipment on site. Dark smoke, which indicates inefficient combustion of fuel within the plant engine, should be avoided to minimise air pollution emission. Follow-up action actions by the Contractor will be checked in the next week's site inspection.

1. Dark smoke was seen rising from the crane truck used to backfill the excavated rocks and soils. The Contractor was reminded to well maintain all plants and equipment on site. Dark smoke, which indicates inefficient combustion of fuel within the plant engine, should be avoided to minimise air pollution emission.

Photo 3 – Dark smoke was seen rising from the crane truck used to backfill the excavated rocks and soils.

Follow-up actions by the Contractor will be checked in next week's site inspection.
