Asia Submarine-cable Express (ASE) – Tseung Kwan O

Second Weekly Site Inspection Report

17 October 2012

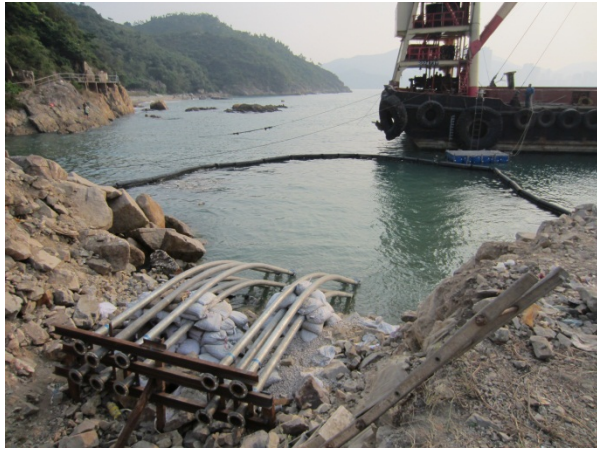
- (i) A copy of EP was displayed conspicuously at the vehicular site entrance in accordance with the requirement of Condition 1.5 of the EP.
- (ii) A silt curtain was employed around the seawall area in order to reduce the dispersion of sediments from the landing site (*Annex D Photo No. 1*).

Photo 1 - A silt curtain was employed around the seawall area.

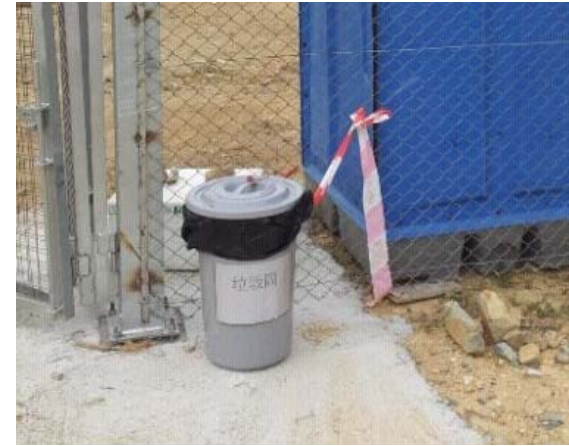
- (iii) During the site inspection, rubbish bins could not be found within the construction site. The Contractor was reminded to provide rubbish bins on site and to educate the workers to dispose rubbish properly. Follow-up actions were conducted in the next day by the Contractor and a rubbish bin was placed on site (*Annex D Photo No. 2*).

Photo 2 - A rubbish bin was placed on site in the next day of site inspection.

1. Open stockpiles/excavated boulders and rocks were found without covers. The Contractor was reminded stockpiles of dusty materials on site should be covered with tarpaulin or similar fabric to prevent excessive dust generation.
2. No rubbish bin was observed to be available on site. The Contractor was reminded to provide rubbish bin on site and educate the workers to dispose rubbish properly.

182. Corrective actions were conducted by the Contractor in the next day. Covering sheet was provided to open dusty stockpiles. Rubbish bin was placed within construction site.

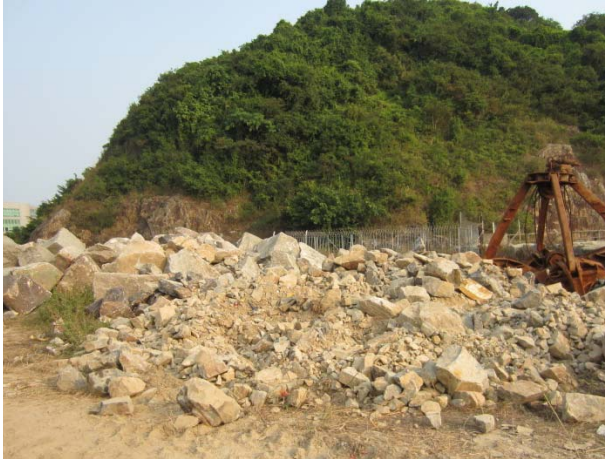
- (iv) Tarpaulin sheets, which should be used to cover unpaved slopes and dusty stockpiles to prevent dust generation or erosion, were observed to be missing on the construction site (*Annex D Photo No. 3*). The Contractor was recommended to cover the stockpiles properly to prevent excessive dust generation. Corrective action was conducted by the Contractor in the following day (*Annex D Photo No. 4*).

Photo 3 - Tarpaulin sheets to cover dusty stockpiles to prevent dust generation were absent from the construction site.

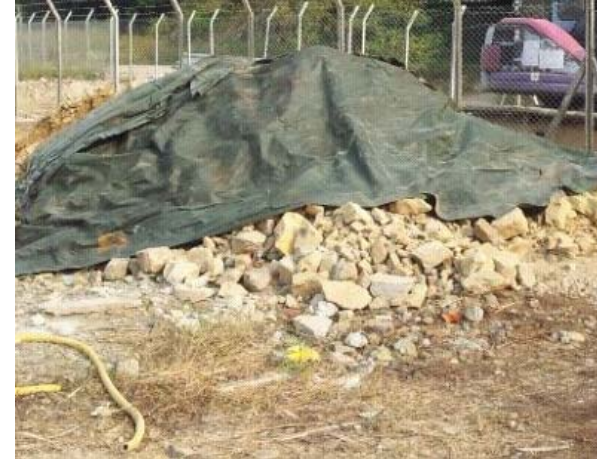
Photo 4 - The corrective action to cover dusty materials was conducted by the Contractor in the following day of site inspection.
