Asia Submarine-cable Express (ASE) – Tseung Kwan O

Fourth Weekly Site Inspection Report

31 October 2012

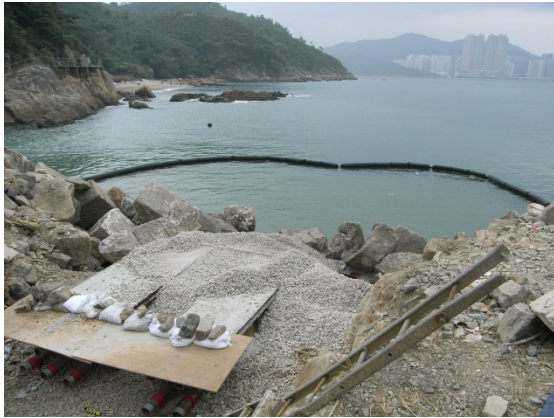
- (i) A copy of EP was displayed conspicuously at the vehicular site entrance in accordance with the requirement of Condition 1.5 of the EP.
- (ii) A silt curtain was employed around the seawall area in order to reduce the dispersion of sediments from the landing site (*Annex D Photo No. 1*).

Photo 1 - A silt curtain was employed around the seawall area.

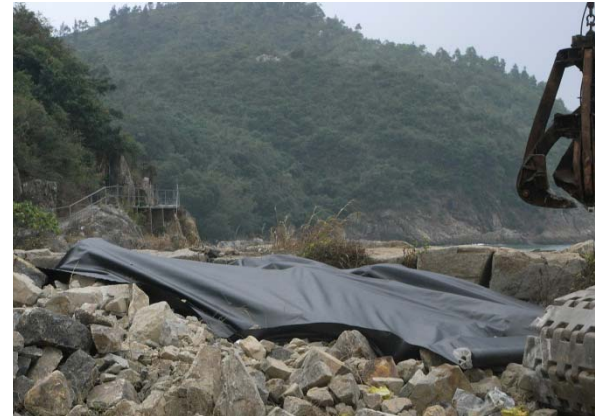
- (iii) Tarpaulin sheets were observed to have been used to cover the excavated materials and open stockpiles (for the part that was not actively used) to prevent dust generation or erosion (*Annex D Photo No. 2*).

Photo 2 - Tarpaulin sheets were observed to have been used to cover excavated materials for the part that was not actively used.

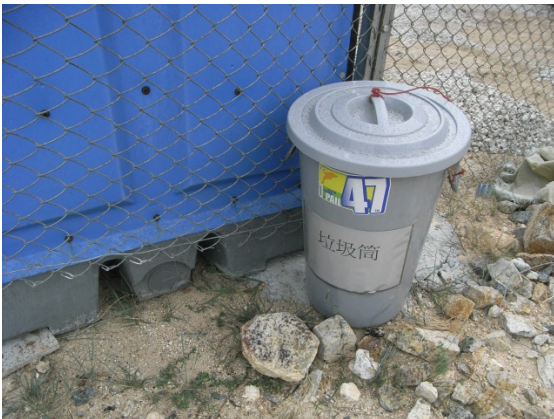
- (iv) Rubbish bin has been provided by the Contractor (*Annex D Photo No. 3*) and the construction site was found to be largely clean and tidy with rubbish seldom seen on site.

Photo 3 - A rubbish bin was provided by the Contractor.

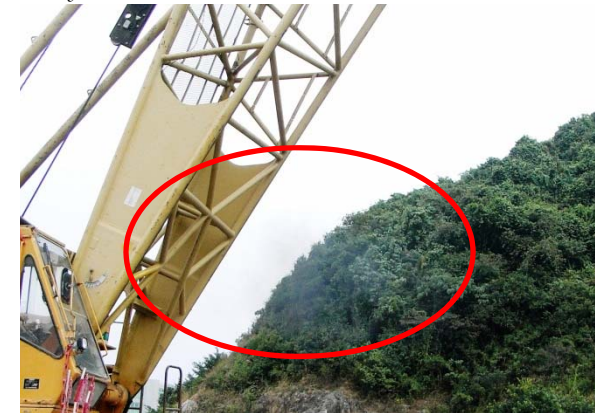
- (v) Dark smoke was seen rising from the crane truck used to restore large boulders back to the opened sea wall (*Annex D Photo No. 4*). The Contractor was reminded to well maintain all plants and equipment on site. Dark smoke, which indicates inefficient combustion of fuel within the plant engine, should be avoided to minimise air pollution emission. Follow-up action actions by the Contractor will be check in the next week's site inspection.

1. Dark smoke was seen rising from the crane truck used to restore large boulders back to the opened sea wall. The Contractor was reminded to well maintain all plants and equipment on site. Dark smoke, which indicates inefficient combustion of fuel within the plant engine, should be avoided to minimise air pollution emission.

Photo 4 - Dark smoke was seen rising from the crane truck used to restore large boulders to the opened sea wall.

Follow-up actions by the Contractor will be checked in next week's site inspection.
