Asia Submarine-cable Express (ASE) – Tseung Kwan O

Ninth Weekly Site Inspection Report

5 December 2012

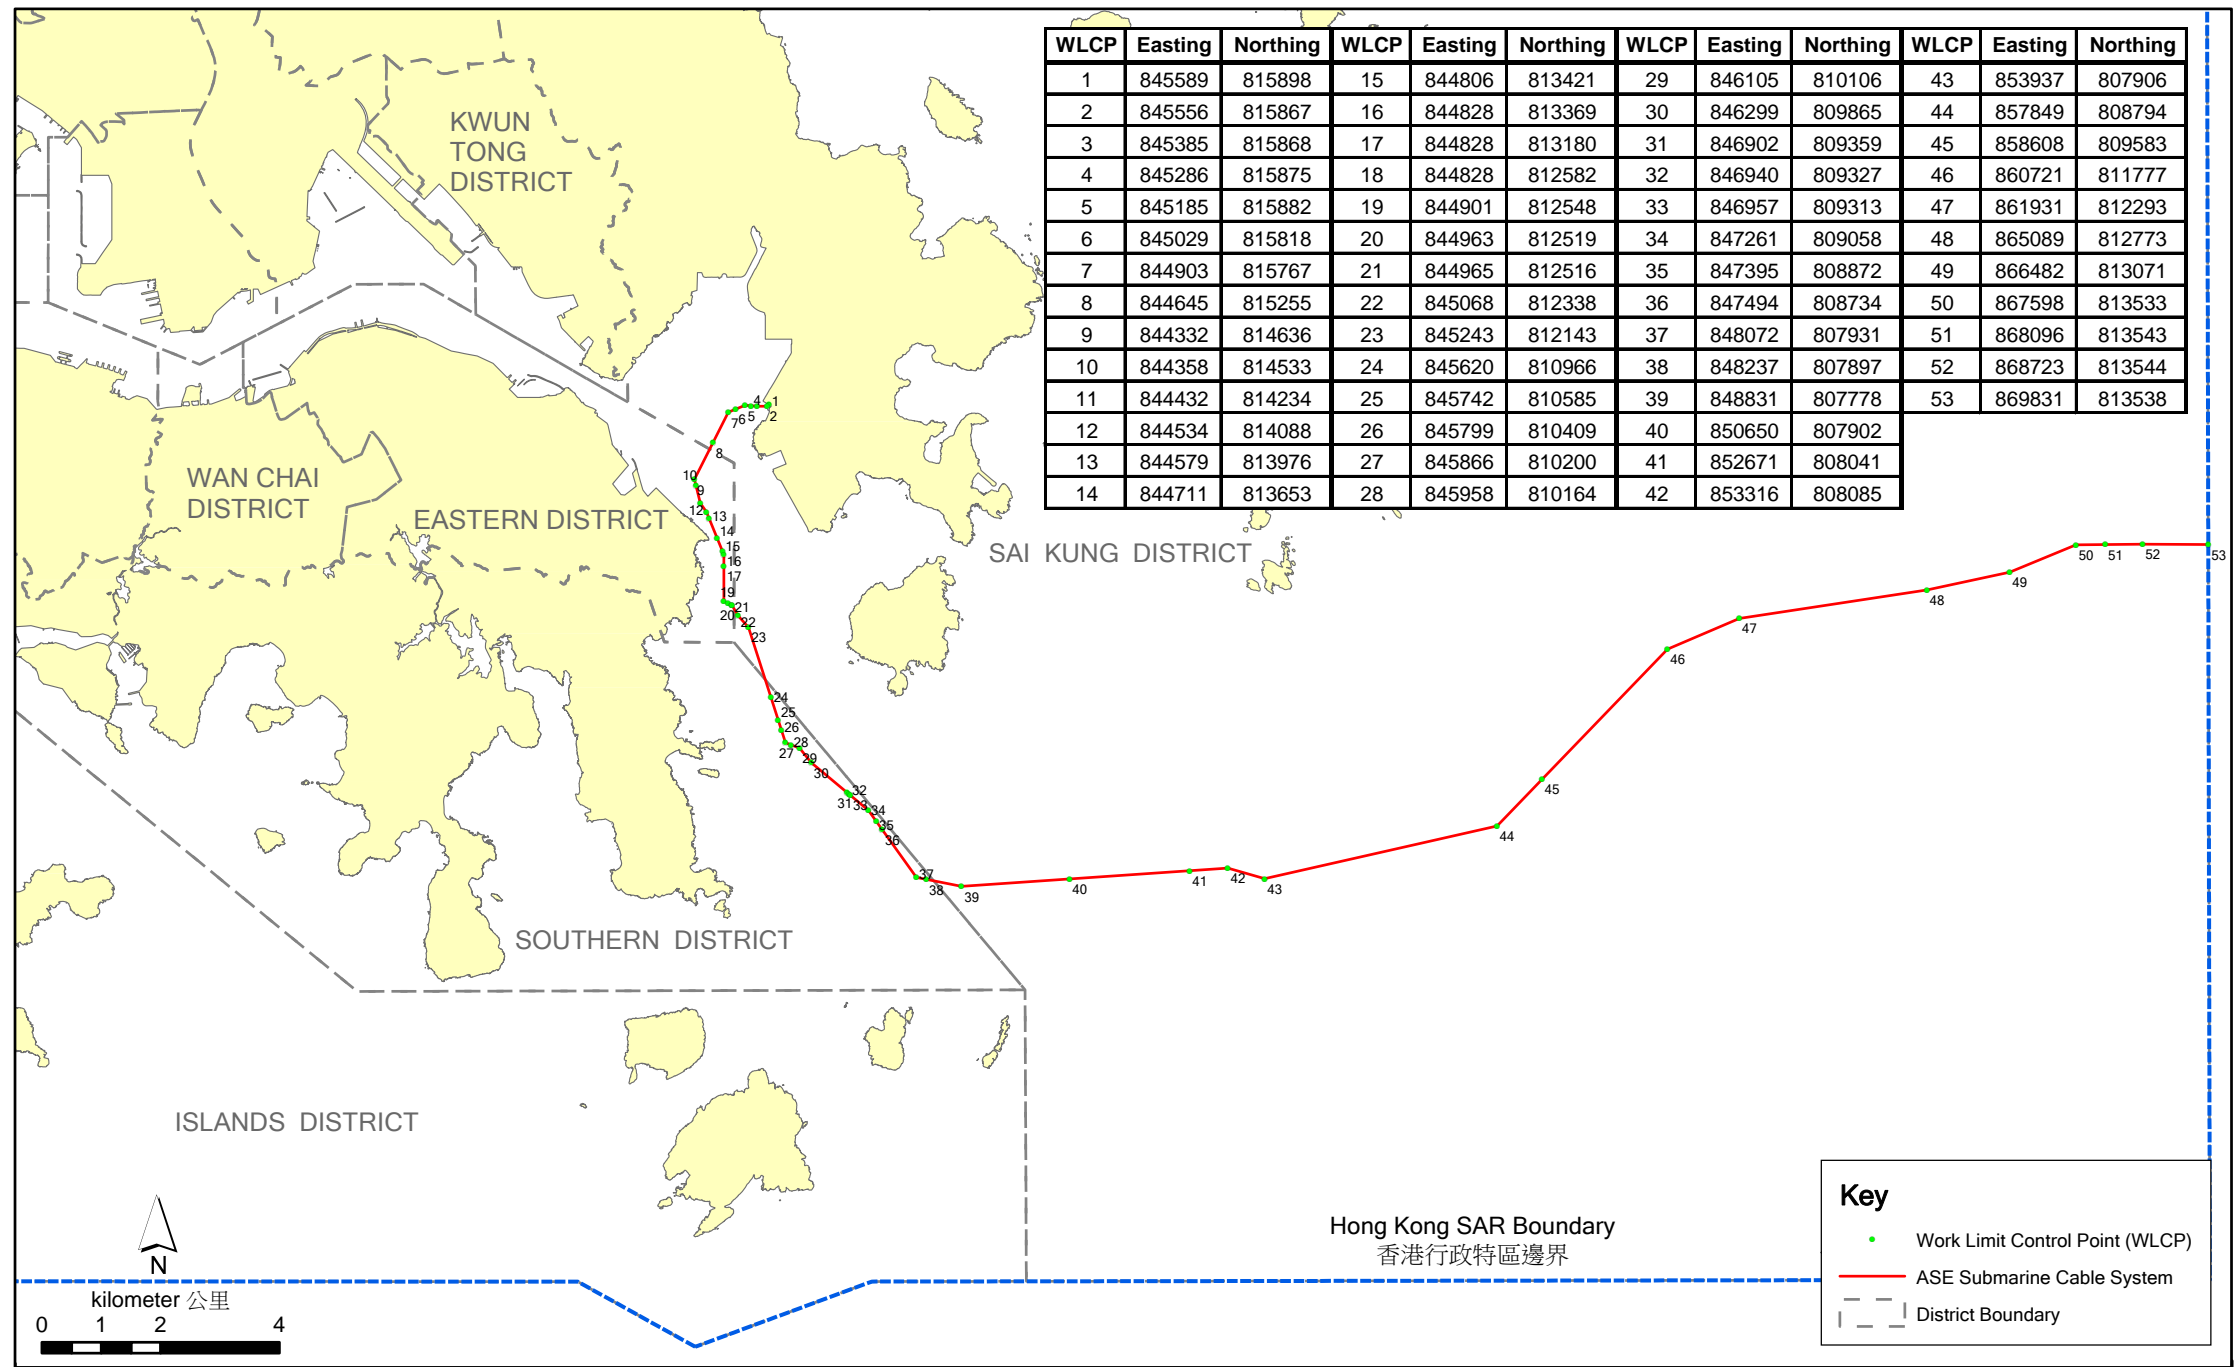
Annex A

- Work Limit Control Point (WLCP)
- ASE Submarine Cable System
- District Boundary

ASE Submarine Cable System (Layout Plan)

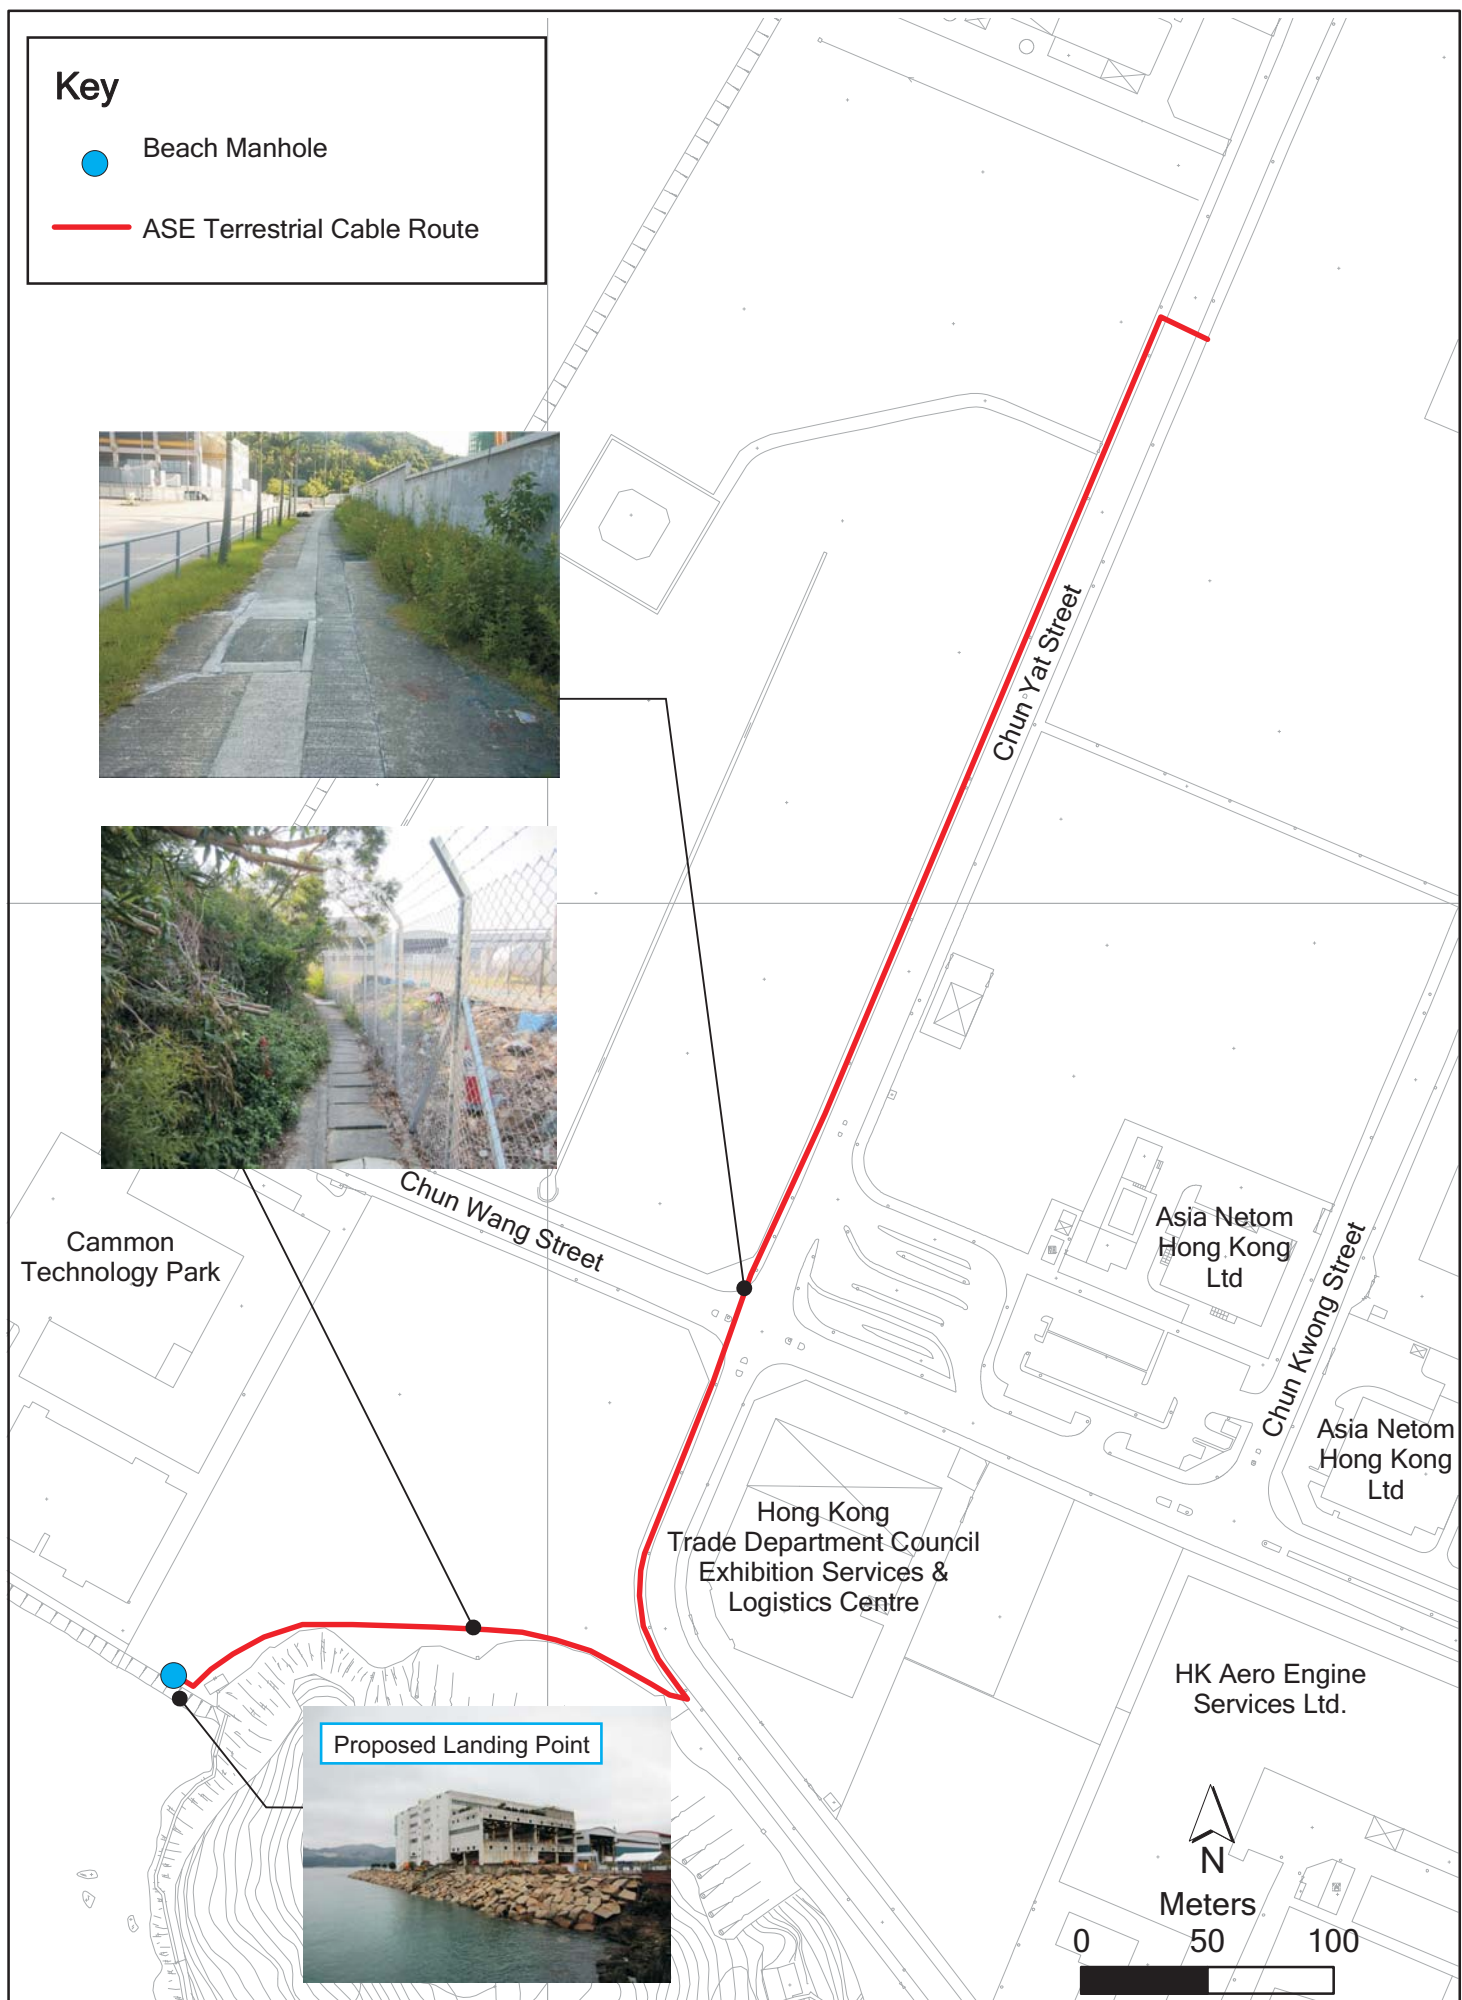
Annex B

Location of ASE Landing Point and Terrestrial Cable Route

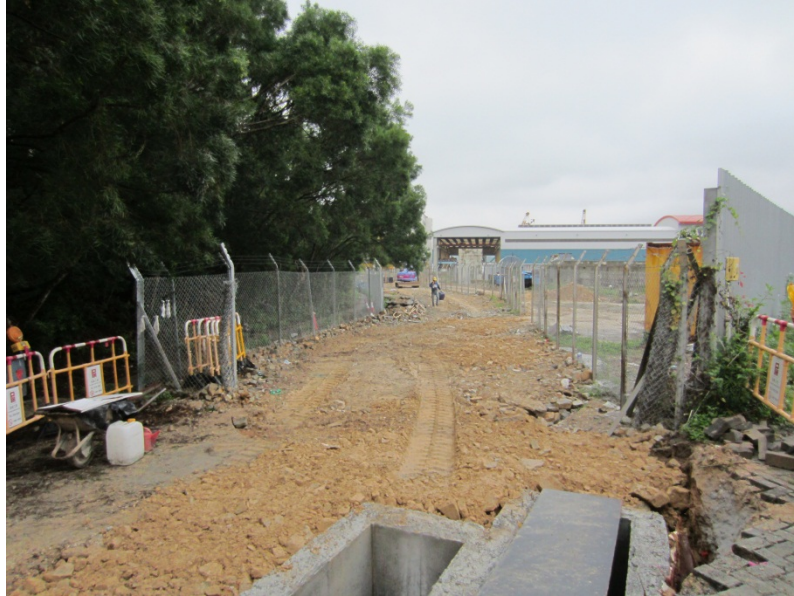
Photo 1 – For the completed section of land duct, excavated materials have been backfilled and the site has been reinstated to its original status.

- (i) A copy of EP was displayed conspicuously at the vehicular site entrance in accordance with the requirement of Condition 1.5 of the EP.
- (ii) Middle section of the land duct was completed. For the completed part, excavated materials have been backfilled into the trench and the site has been reinstated to its original status (*Annex D Photo No. 1*).
- (iii) Impermeable sheets were observed to have been placed in some portions of the stockpiles of excavated soils and rocks, but large portion of stockpiles were still exposed under the rain (*Annex D Photo No. 2*). The Contractor was reminded to cover all stockpiles completely during rain events to prevent storm runoff, which would transport the sediment and eventually deposit it in nearby sea water, storm drains or low-lying areas.

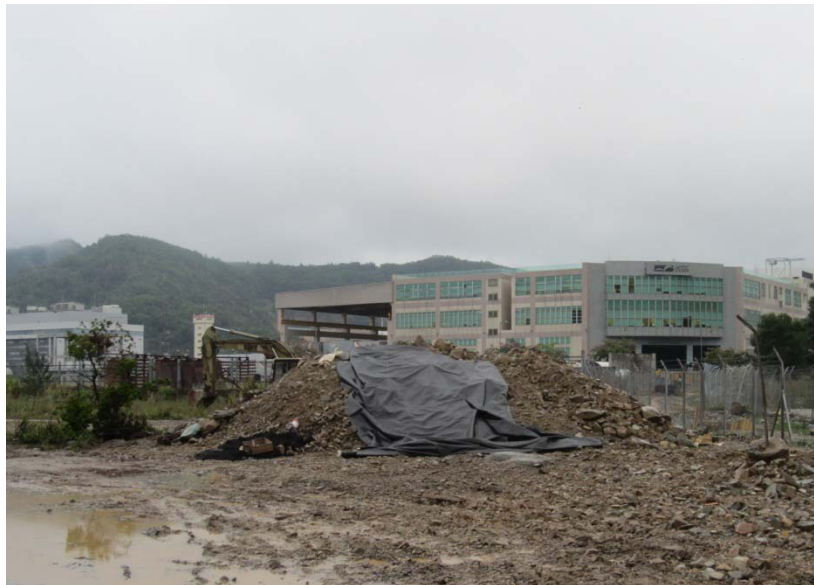
1. Stockpiles of the excavated soils and rocks from the new beach manhole and land duct were observed to be partly exposed during the rain. The Contractor was reminded to cover the stockpiles completely during rain events to prevent storm runoff, which transports the sediment and eventually deposit it in nearby sea water, storm drains or low-lying areas.

Photo 2 – Some stockpiles of the excavated soils from the new beach manhole and land duct were partly exposed in the rain.

Follow-up actions by the Contractor will be checked in next week's site inspection.
